## WASTE<sub>2</sub>O

# Yorkshire Water's clear vision with Waste<sub>2</sub>O™

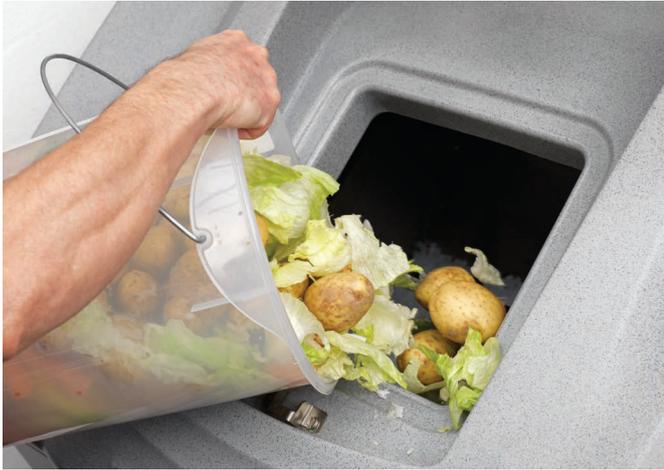
Waste food is fed into the machine in regular amounts.

In **Waste<sub>2</sub>O**, the microorganisms digest food waste aerobically. Unlike composting and anaerobic digestion processes, which result in a compost or compost-like digestate, the low-density, liquid digestate from the **Waste<sub>2</sub>O**, goes straight to drain. Each unit can ‘digest’ 180kgs of waste per day, starting the break down of fats, oils and greases which can block drains. Running costs are in the

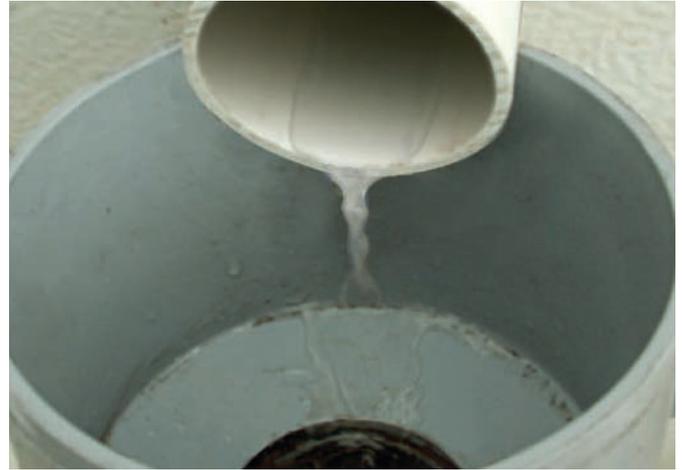
The output is grey water which runs into the drain.

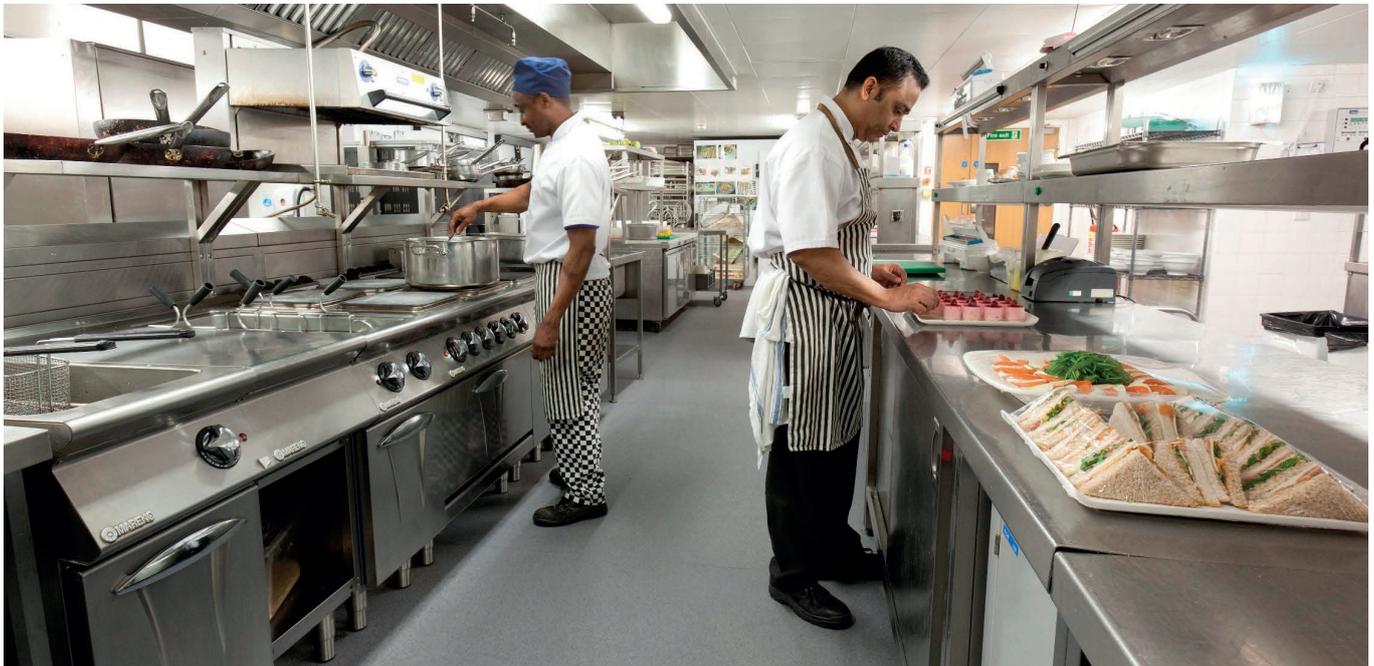
One Waste<sub>2</sub>O machine can cope with the output from a busy commercial kitchen.
