# GREASEPAK

## The Proof is *still* in the Pub! GreasePak continues to successfully tackle FOG problem site, one year on from historic year-long trial with Southern Water

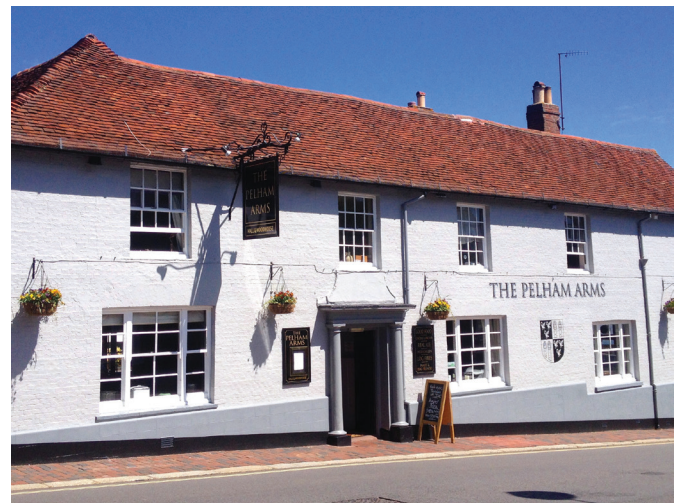
The Pelham Arms pub in Lewes, owned by Hall and Woodhouse Brewery, had experienced a FOG predicament and substantial looming fine for two and a half years as a result of inappropriate FOG management. They had their site attended to repeatedly by Southern Water as a result of FOG blockages and flooding to the surrounding residential area. And although initially the pub had no grease management system in place, when a grease trap was later installed on the request of Southern Water it did not eradicate the problem.

The grease trap proved ineffective in preventing FOG reaching the public sewer, with further blockages and the spillage of foul sewage eight months later. It was clear to all involved that an alternative form of action was required. Andrew Mellor, landlord of The Pelham Arms, affirmed: *“We had history of sewer blockage issues caused from FOG emanating from our pub kitchen. A traditional*

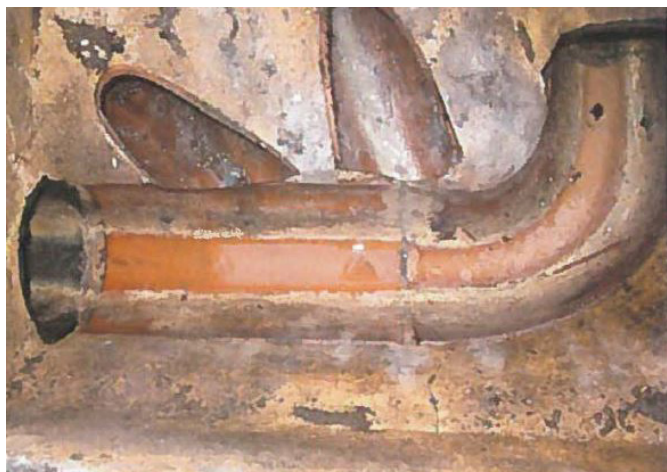
The clear sewer run at the end of the year-long trial, April 2017.

In May 2016 Southern Water began a year-long trial with the installation of two **GreasePaks** one for each outlet from the kitchen, as recommended by Mechline following an onsite survey. Staff were made aware of how to use and maintain the **GreasePak** as well as trained with kitchen best practice – 'Stop and think, not down the sink!' Southern Water constantly monitored the sewers via CCTV over the 12 month period and

on its completion reported that the trial of the **GreasePak** system at The Pelham Arms had proven successful.

**GreasePak** proved to keep the sewer free from FOG with no discernible build-up evidential, a result not previously achieved with the installation of a grease trap!

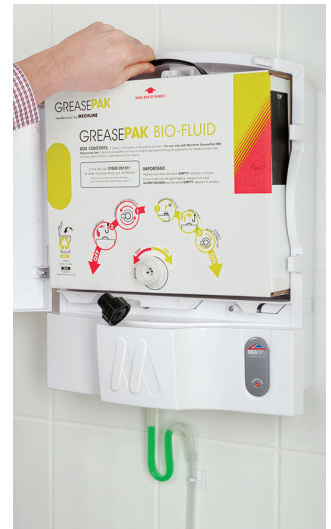
**The sewer remains clear, 2 years after GreasePak first installed, May 2018.**

Six months after the trial had concluded, and then again at 12 months, Southern Water and Mechline returned to The Pelham Arms and drains were once again inspected via CCTV. It was evident from the footage that the sewer runs were no worse than in prior inspections. **GreasePak** had remained to keep the sewer free from FOG build-up – two years after installation!
