HYGENIKX[®]

HyGenikx Proves Its Power at Two Quick-Service Restaurants in South East Asia

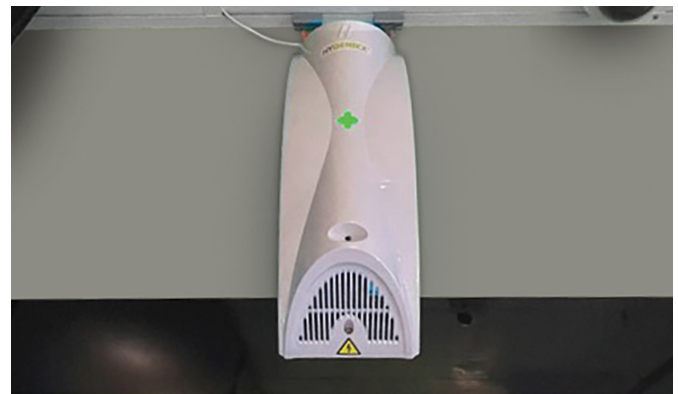
Test Site A is a QSR specialising in sandwiches and wraps, prepared onsite, with lots of options of fillings. The **HyGenikx** unit (HGX-W-30F)

was installed in the main service and food assembly area.

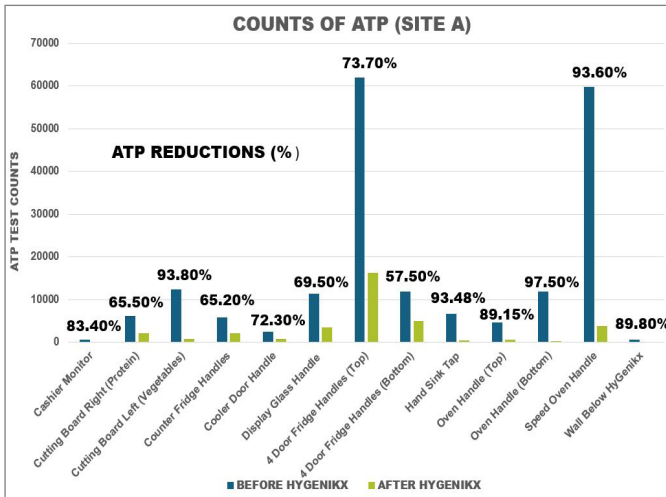
The Results were impressive, with very high reductions in microbial counts demonstrated after **HyGenikx** was installed (e.g. 94%, 84%, 73%, 94%, 89%, 97%, 94%, 90%), even during normal operational hours.

Test Points	BEFORE HYGENIKX ATP Test Counts	AFTER HYGENIKX ATP Test Counts	REDUCTIONS %
Cashier Monitor	566	94	83.40%
Cutting Board Right (Protein)	6151	2122	65.5%
Cutting Board Left (Vegetables)	12311	757	93.80%
Counter Fridge Handles	5832	2029	65.20%
Cooler Door Handle	2462	681	72.30%
Display Glass Handle	11340	3459	69.50%
4 Door Fridge Handles (Top)	61945	16278	73.70%
4 Door Fridge Handles (Bottom)	11817	5020	57.5%
Hand Sink Tap	6692	436	93.48%
Oven Handle (Top)	4690	509	89.15%
Oven Handle (Bottom)	11926	301	97.50%
Speed Oven Handle	59713	3799	93.60%
Wall Below HyGenikx	629	64	89.8%

The results also highlighted potential cross-contamination hotspots—namely the cutting board and various fridge handles. It is thought that the fridge door handles could have been maintaining a high score due

to the amount of traffic being directed to these touch points, although still notably improved with **HyGenikx** installed!

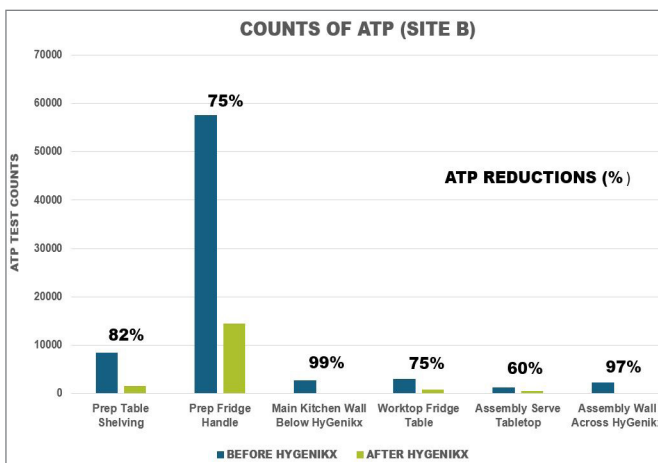
The results were again very good. There were very high reductions in microbial counts demonstrated after **HyGenikx** units were installed

Test Points	BEFORE HYGENIKX ATP Test Counts	AFTER HYGENIKX ATP Test Counts	REDUCTIONS %
Prep Table Shelving	8500	1515	82%
Prep Fridge Handle	57580	14463	75%
Main Kitchen Wall Below HyGenikx	2779	20	99%
Worktop Fridge Table	3074	758	75%
Assembly Serve Tabletop	1306	527	60%
Assembly Wall Across HyGenikx	2334	69	97%

(e.g. 99%, 82%, 75%, 97%). This was again impressive as this was the case even during normal operational hours.

The tests had also highlighted two potential cross-contamination hotspots: the assembly table top and preparation fridge handles. It is reasoned that the preparation fridge door handles could have been maintaining a high score due to the amount traffic directed to this touch point, in combination with the potential of raw produce being handled.
